STRUCTURAL INVESTIGATIONS ON THE PROGRESSIVE COLLAPSE OF A STEEL-TIMBER INTERMEDIATE ROOFING

Key words: steel-timber truss, construction error, accidental collapse, experimental testing, forensic investigation.

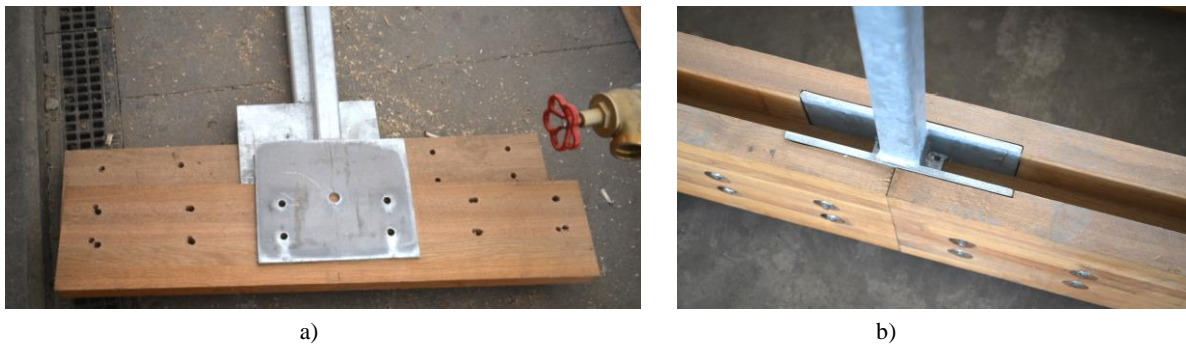
The beam sections were joined using double-shear steel-to-timber and timber-to-timber connections made of M12 bolts class 8.8 and 5×20 cm timber elements (called link elements) with a length of 1.0 m between T1-T2 and 1.20 m between T2-T3 and T3-T4. The steel posts had two welded gussets of 10 mm thickness each at the top (Fig. 4a). Intermediately, the twin beam sections were connected using 5×20 and 30 cm long timber elements, which also served to support the top brackets used to fix the purlins. Although both the link elements and the timber beams were originally designed to be built with oak wood, the solution was subsequently changed to glued laminated timber elements. Ties were made from round steel bars with a diameter of 20 mm while the posts were built with 50×50×5 mm square tubes. To allow tightening, the ties were threaded at both the beam ends and supplied with nuts and washers. All the steel elements were composed of S235 JR steel (EN 10025-2). The beam splicing was configured so that only one bolt row connected the timber sections through the gusset plates (Fig. 4b).

Fig. 4 – Splice connection: a) steel post with link steel and timber elements; b) beam ready for erection.

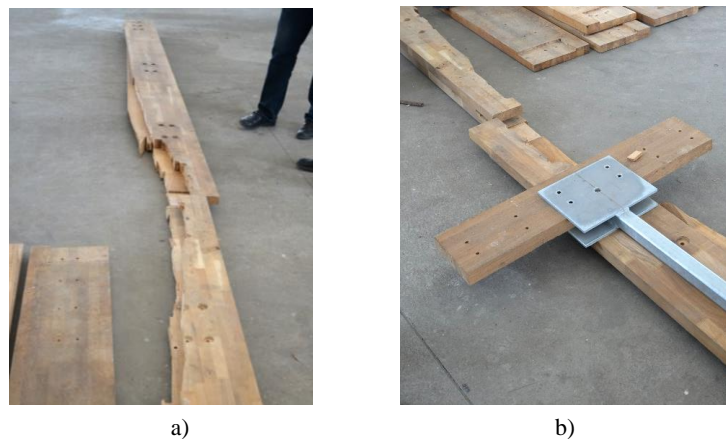
During a visit at the construction site after the accident, sections of the beam that initially failed were identified and assembled to reconstruct the beam (Fig. 5a). The reconstruction revealed that the fracture had occurred at the splice connection between sections T1 and T2 of the beam (see Fig. 6 for identification of the beam sections). There was no evidence of any damaged or broken link. However, one such element was identified as the most probable part of the failed connection, as it exhibited localized tear-out damage in the first row of bolts (Fig. 5b).

Fig. 5 – Two sections of the beam reconstructed after the failure: a) view with the elements on the ground; b) connecting device with the post, two gusset plates, and timber link element.

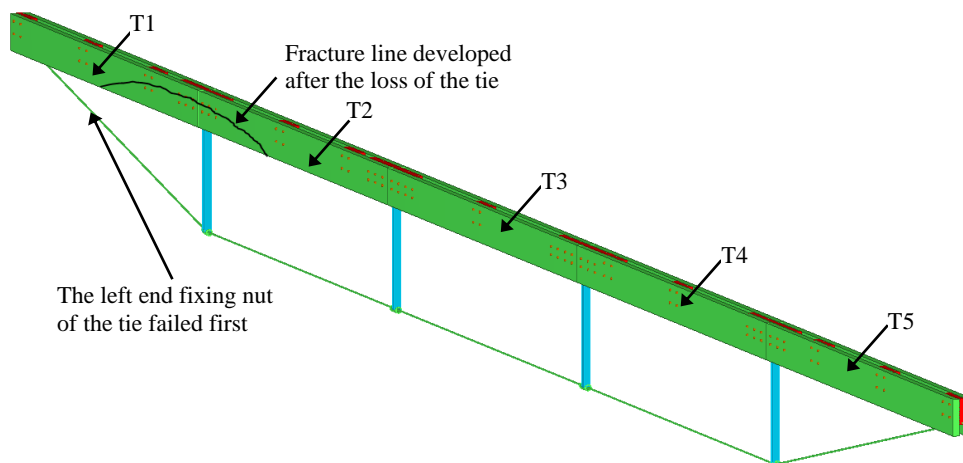
Fig. 6 – The initiation of collapse in beam from axis 3, between section T1 and T2 (the fracture line is also sketched).

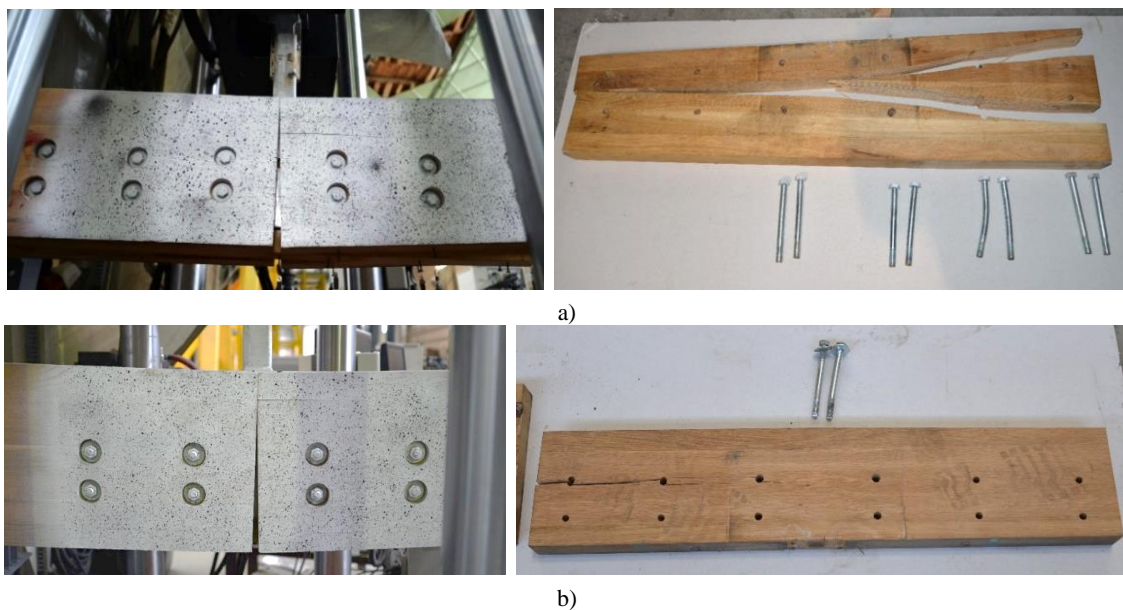
Fig. 9a shows the force-displacement curves for specimens S1 and S2, while Fig. 10 shows the failure mode for the same specimens. In case of specimen S1, a partial failure (most probably a partial split of the timber link) was observed at a force equal to 24.4 kN, where it dropped to 13.10 kN. Subsequently, the capacity increased until the final fracture of the link element owing to a complete split at a maximum force of 30.5 kN (Fig. 10a). This failure mode, also called “zip-effect”, appears when a splitting-failure of one fastener makes the subsequent fasteners in a row to fail. The bending moment at the maximum applied force was 25.10 kNm. Only a partial longitudinal crack was observed in the upper area of the beam elements because of compression, a crack that propagated longitudinally up to the second bolt row. It is also visible in the figure that the deformation of the bolts is larger in the second bolt row from the right-hand area, indicating an uneven transfer of shear loads within the hybrid steel-timber connection. In case of specimen S2, the peak applied force was 29.70 kN, very close to that obtained for specimen S1, and the corresponding bending moment was 24.40 kNm. The splitting of the link element within the larger span caused the failure as shown in Fig. 10b. Only partial cracks developed in the upper area of the beam upon compression.

Fig. 10 – Failure mode: a) specimen S1; b) specimen S2.

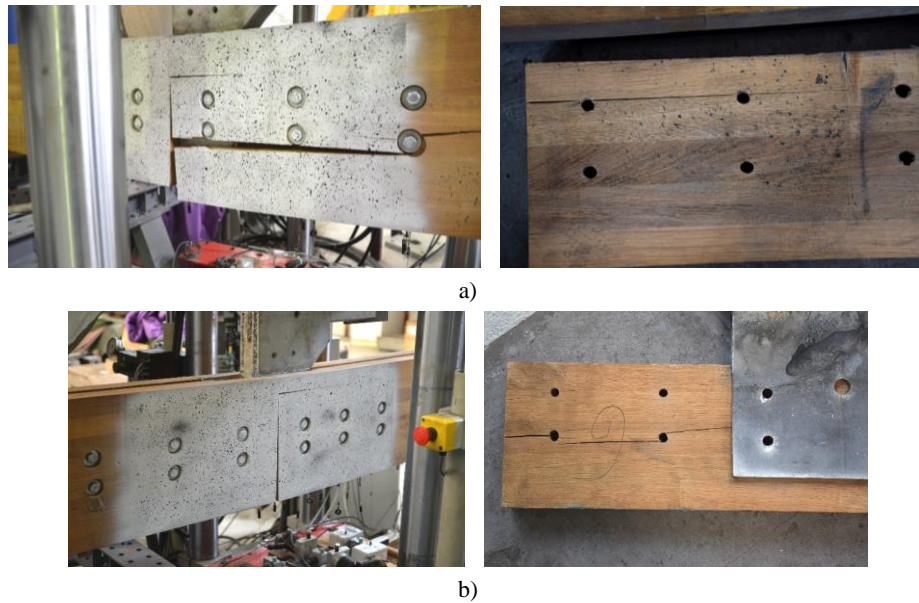
cracks first initiated in the upper compressed area of the beam, which then propagated up to the second bolt row; however, they did not cause a significant decrease in the beam capacity. The failure was produced owing to the splitting of the beam from the larger span (Fig. 11a). The maximum force was 31.6 kN, after which the capacity dropped sharply to 20 kN. The test was terminated when the vertical displacement reached 78 mm. The maximum bending moment was 33.80 kNm. No cracks were observed in the link element. As the fracture developed in the beam elements and not in the link, it was possible to observe the initiation and propagation of the cracks in the connection up to the failure point. Thus, the initiation started inside the beam, between the second and the third bolt row, after which it propagated beyond the second bolt row and finally the failure was caused by the beam splitting, as seen in Fig. 12. In case of specimen S4, the first crack formed in the upper compressed area of the beam, which then propagated up to the second bolt row; however, it did not produce a significant decrease in the beam capacity. Splitting of the link element from the larger span for almost half the length caused the failure, as seen in Fig. 11b. The maximum force value was 32.9 kN, after which the capacity dropped sharply, and the test was terminated. The maximum bending moment was 35.2 kNm.

Table 1 summarizes the peak force applied in each test and the corresponding maximum bending moment. Notably, three specimens (S1, S2, S4) failed owing to the splitting of the link element, while the failure of specimen S3 was caused by the splitting of the beam. However, the maximum applied forces were very similar, indicating that the resistance of the beam matches very closely with that of the link element. Therefore, the bearing capacity of the joint can be increased only by increasing the capacities of both the beams and link elements.

Fig. 11 – Failure mode: a) specimen S3; b) specimen S4.

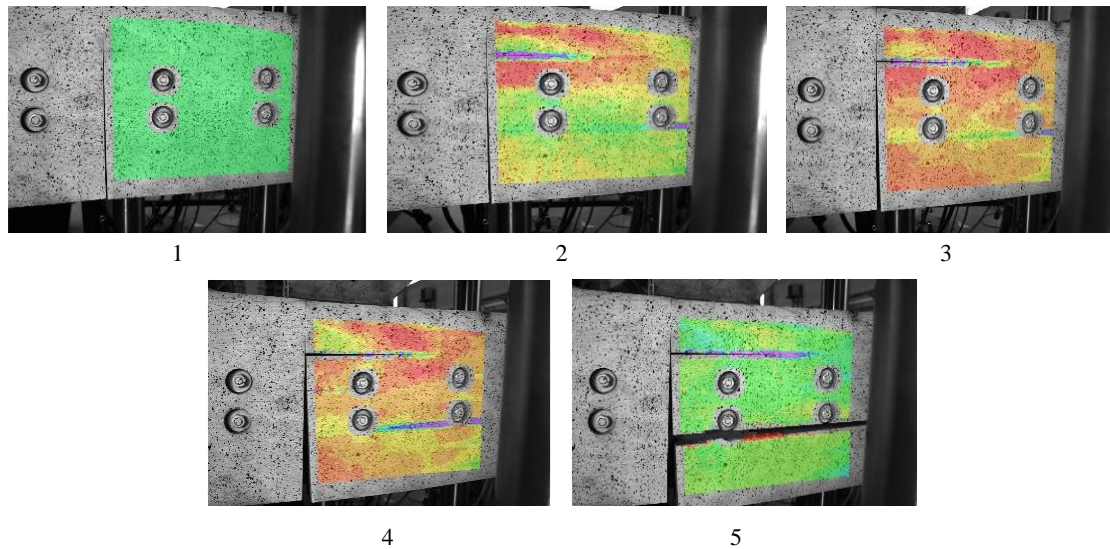
Fig. 12 – Initiation and development of cracks measured with VIC-3D system, specimen S3 (from 1 to 5).

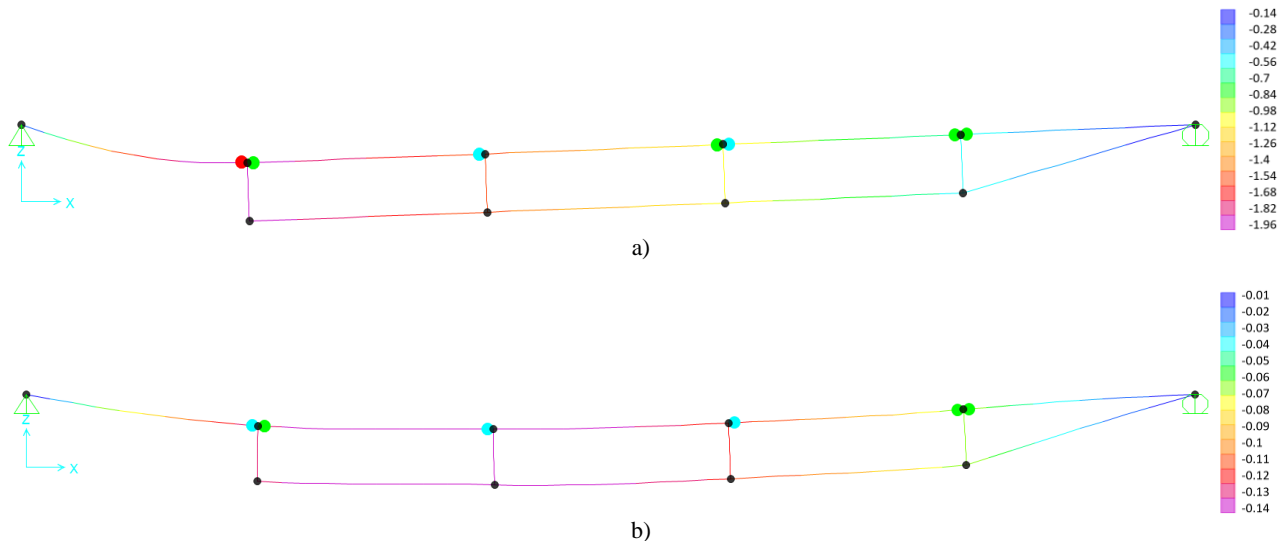
As seen from Fig. 15a, after the tie is lost, the timber beam alone cannot support the applied gravity loads and fails at the first intermediate splice. Notably, the same point of fracture was identified on the site (Fig. 5a). Moreover, the instantaneous removal of the tie exposed the structure to a dynamic effect, and thus much greater loads were imposed on the structure. For comparison, Fig. 15b shows the deformed shape of the beam in the case of a quasi-static removal of the tie. Even when the vertical deflection reaches 148 mm, the bearing capacity of the connections is not exceeded, and the failure is prevented.

Fig. 15 – Deformed shape of the beam and distribution of plastic hinges in splice connections: a) removal time $\Delta t = 0.001$ s; b) quasi-static removal (the scale indicates the vertical deflection, in m).
