STRUCTURAL INVESTIGATIONS ON THE PROGRESSIVE COLLAPSE OF A STEEL-TIMBER INTERMEDIATE ROOFING

Key words: steel-timber truss, construction error, accidental collapse, experimental testing, forensic investigation.

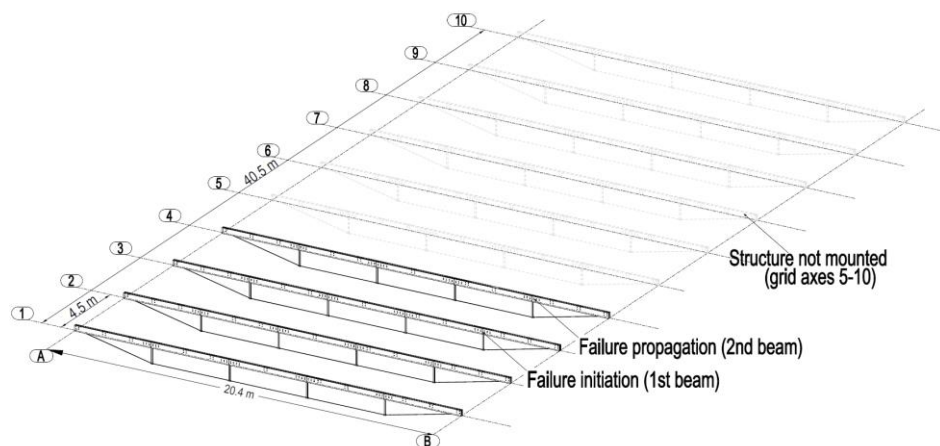
The structure under investigation was a new intermediate roof being built inside an existing open-air market located in Timisoara, Romania (see Fig. 1). This intermediate roof was designed to protect the commercial space from severe weather conditions. The roof, constructed with glued laminated timber beams and steel posts and ties (Fig. 2), partially collapsed during the erection phase when a transversal beam fractured and resulted in the failure of the adjacent beam (see Fig. 1). The beams, with a total span of 20.40 m, comprised five sections joined on-site with a hybrid timber-steel bolted connection (see Fig. 3). The supports at both the beam ends were pinned. The beam sections, denoted as T1 to T5, were of almost equal length (T1, T5 = 4.05 m; T2, T3, T4 = 4.10 m). Each beam section contained two individual beams (pair section), each 5 cm thick, joined at each splice connection. The timber beam was a symmetrical double-pitched beam with the following dimensions:

Fig. 1 – 3D view of the intermediate roof structure.

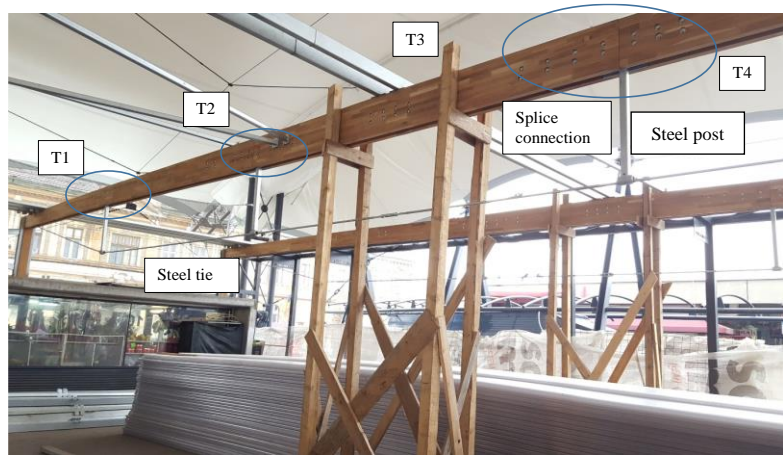
Fig. 2 – View of the first two beams (axis 1, axis 2) with the temporary supporting structures still in position.

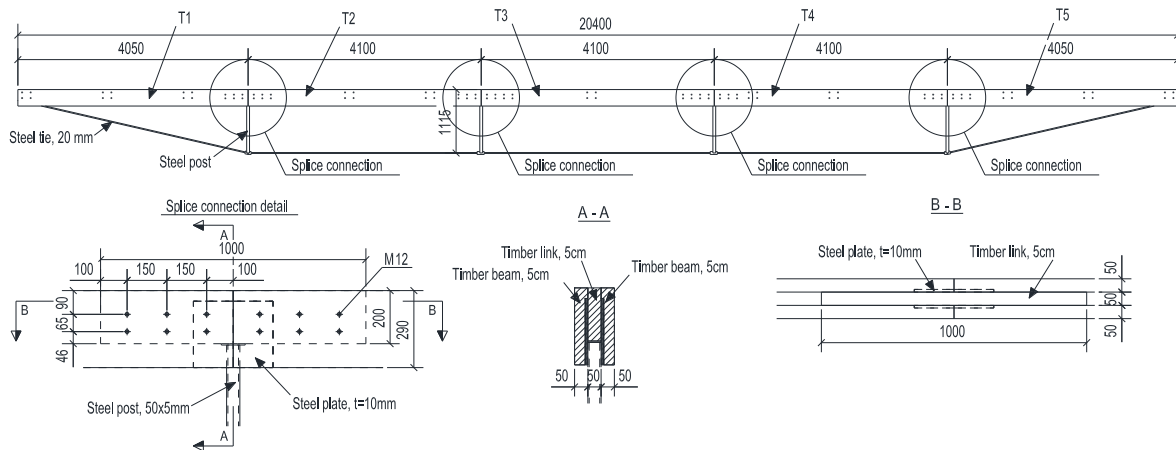
- T1, T5: height varied from 25 cm at the outer end to 29 cm at the inner end;
- T2, T4: height varied from 29 cm at the outer end to 33.50 cm at the inner end;
- T3: height varied from 33.50 cm at both ends to 35.50 cm in the middle section.

The beam sections were joined using double-shear steel-to-timber and timber-to-timber connections made of M12 bolts class 8.8 and 5×20 cm timber elements (called link elements) with a length of 1.0 m between T1-T2 and 1.20 m between T2-T3 and T3-T4. The steel posts had two welded gussets of 10 mm thickness each at the top (Fig. 4a). Intermediately, the twin beam sections were connected using 5×20 and 30 cm long timber elements, which also served to support the top brackets used to fix the purlins. Although both the link elements and the timber beams were originally designed to be built with oak wood, the solution was subsequently changed to glued laminated timber elements. Ties were made from round steel bars with a diameter of 20 mm while the posts were built with 50×50×5 mm square tubes. To allow tightening, the ties were threaded at both the beam ends and supplied with nuts and washers. All the steel elements were composed of S235 JR steel (EN 10025-2). The beam splicing was configured so that only one bolt row connected the timber sections through the gusset plates (Fig. 4b).

Fig. 3 – Geometry of the beam and fabrication details.

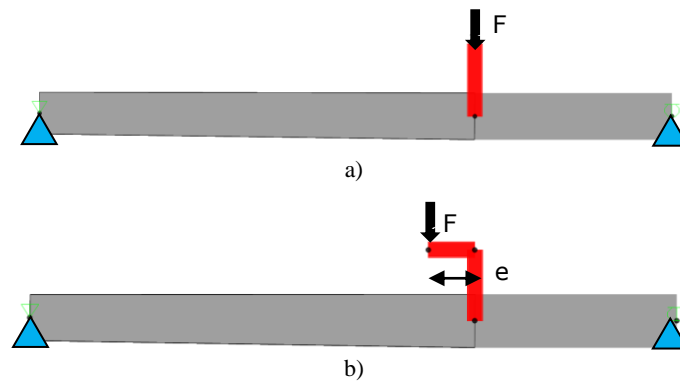
two spans, 2.85 m and 1.20 m, respectively. For specimens S1 and S2, the load was applied on top of the post (Fig. 7a), whereas it was applied with an eccentricity e of 0.35 m for S3 and S4 (Fig. 7b). The different loading setup aimed at evaluating the possible effects of bending/shear ratio on the peak capacity and failure mode.

Fig. 7 – Loading setup for experimental testing: a) specimens S1, S2; b) specimens S3, S4.

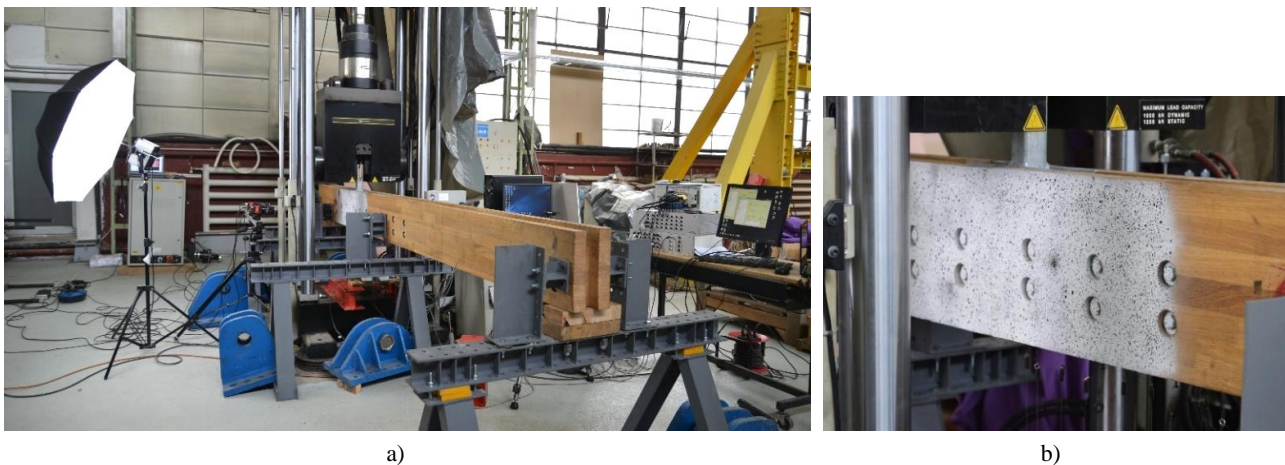
The vertical load was applied quasi-statically using a displacement control protocol and was gradually increased until the failure of the test specimens (Fig. 8a). The amplitude of the load was monitored using the load cell of the actuator. The instrumentation used during testing comprised two main components, namely, displacement transducers and a digital image correlation system produced by Correlated Solutions, Inc. (VIC-3D) [14] (Fig. 8b).

Fig. 8 – View from laboratory: a) test setup and specimen ready for testing; b) surface preparation for VIC-3D measurements.

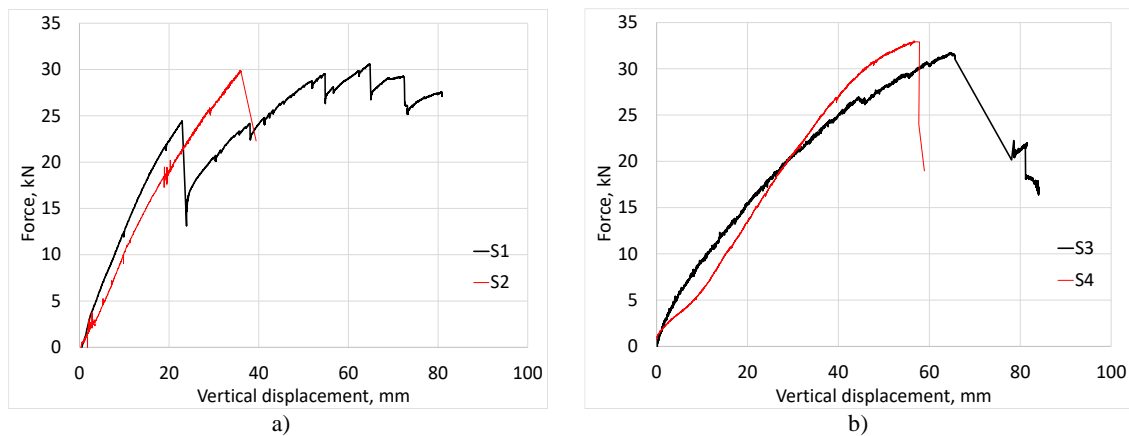
Fig. 9a shows the force-displacement curves for specimens S1 and S2, while Fig. 10 shows the failure mode for the same specimens. In case of specimen S1, a partial failure (most probably a partial split of the timber link) was observed at a force equal to 24.4 kN, where it dropped to 13.10 kN. Subsequently, the capacity increased until the final fracture of the link element owing to a complete split at a maximum force of 30.5 kN (Fig. 10a). This failure mode, also called “zip-effect”, appears when a splitting-failure of one fastener makes the subsequent fasteners in a row to fail. The bending moment at the maximum applied force was 25.10 kNm. Only a partial longitudinal crack was observed in the upper area of the beam elements because of compression, a crack that propagated longitudinally up to the second bolt row. It is also visible in the figure that the deformation of the bolts is larger in the second bolt row from the right-hand area, indicating an uneven transfer of shear loads within the hybrid steel-timber connection. In case of specimen S2, the peak applied force was 29.70 kN, very close to that obtained for specimen S1, and the corresponding bending moment was 24.40 kNm. The splitting of the link element within the larger span caused the failure as shown in Fig. 10b. Only partial cracks developed in the upper area of the beam upon compression.

Specimens S3 and S4 were tested by eccentrically applying an increasing vertical force (eccentricity $e = 0.35$ m). Fig. 9b shows the force-displacement curves for the two specimens. In case of specimen S3, the

cracks first initiated in the upper compressed area of the beam, which then propagated up to the second bolt row; however, they did not cause a significant decrease in the beam capacity. The failure was produced owing to the splitting of the beam from the larger span (Fig. 11a). The maximum force was 31.6 kN, after which the capacity dropped sharply to 20 kN. The test was terminated when the vertical displacement reached 78 mm. The maximum bending moment was 33.80 kNm. No cracks were observed in the link element. As the fracture developed in the beam elements and not in the link, it was possible to observe the initiation and propagation of the cracks in the connection up to the failure point. Thus, the initiation started inside the beam, between the second and the third bolt row, after which it propagated beyond the second bolt row and finally the failure was caused by the beam splitting, as seen in Fig. 12. In case of specimen S4, the first crack formed in the upper compressed area of the beam, which then propagated up to the second bolt row; however, it did not produce a significant decrease in the beam capacity. Splitting of the link element from the larger span for almost half the length caused the failure, as seen in Fig. 11b. The maximum force value was 32.9 kN, after which the capacity dropped sharply, and the test was terminated. The maximum bending moment was 35.2 kNm.

Table 1 summarizes the peak force applied in each test and the corresponding maximum bending moment. Notably, three specimens (S1, S2, S4) failed owing to the splitting of the link element, while the failure of specimen S3 was caused by the splitting of the beam. However, the maximum applied forces were very similar, indicating that the resistance of the beam matches very closely with that of the link element. Therefore, the bearing capacity of the joint can be increased only by increasing the capacities of both the beams and link elements.

Fig. 9 – Experimental force-displacement curves: a) specimens S1, S2; b) specimens S3, S4.

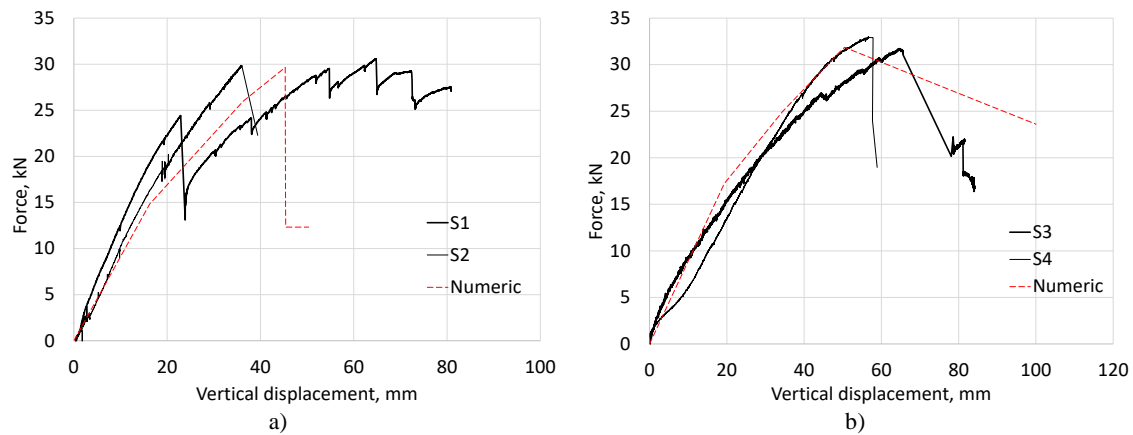
were assigned to the beam sections, that is, shear V_2 and moment M_3 , both uncoupled. Figure 13 shows the comparative force-displacement curves in the nonlinear static analysis and experimental testing. The numerical models accurately estimated the initial stiffness, maximum force, and corresponding maximum displacement.

Fig. 13 – Force-displacement curves, experimental vs. numeric: a) specimens S1, S2; b) specimens S3, S4.

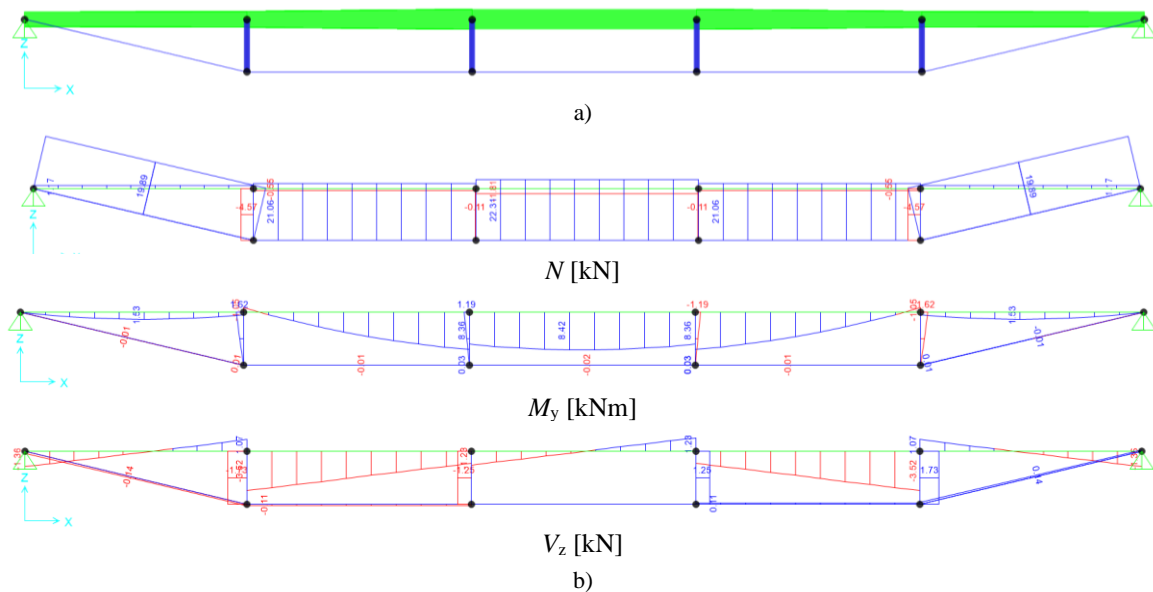
To determine the distribution of forces in the beam, a complete model of the beam assembly was obtained by integrating the joint models (Fig. 14a). The geometric and material characteristics were obtained from the technical project and the test report provided by Urban Incerc Timisoara (2017). Considering that the beam was not loaded with any imposed load at the time of collapse, the beam was first analyzed for the effects of gravity load caused by the self-weight of the beam assembly, which was then increased by 50% to account for possible deviations from the nominal weight and other materials/tools used during the construction stage. A static analysis was applied to determine the maximum values of forces and bending moments in the timber elements, steel post, and ties at the time of failure. As can be seen from Fig. 14b, the values of the bending moment and shear force are lower than the peak values recorded during experimental testing, which eliminates them as the source of failure. However, the axial force, which amounts to 19.89 kN, is higher than the minimum resistance measured for the threaded rods (13.38 kN). In these conditions, the failure most probably initiated from the steel tie, which failed suddenly in tension under the effect of the gravity load. To investigate the removal effect on the structure, a two-stage analysis was performed to assess if the complete structural collapse was triggered by the failed tie. In the first stage, the gravity load (multiplied by a safety factor of 1.5) was applied to the structure. In the second stage, the tie was removed almost instantly ($\Delta t = 0.001$ s). The response of the remaining structure was then evaluated using a non-linear dynamic time history analysis.

Fig. 14 – Hybrid timber-steel beam model in SAP2000: a) complete beam model; b) axial force, in-plane bending moment M_y , and shear force V_z under gravity loads due to self-weight.
